Flight Data Recorder (FDR)

NTSB

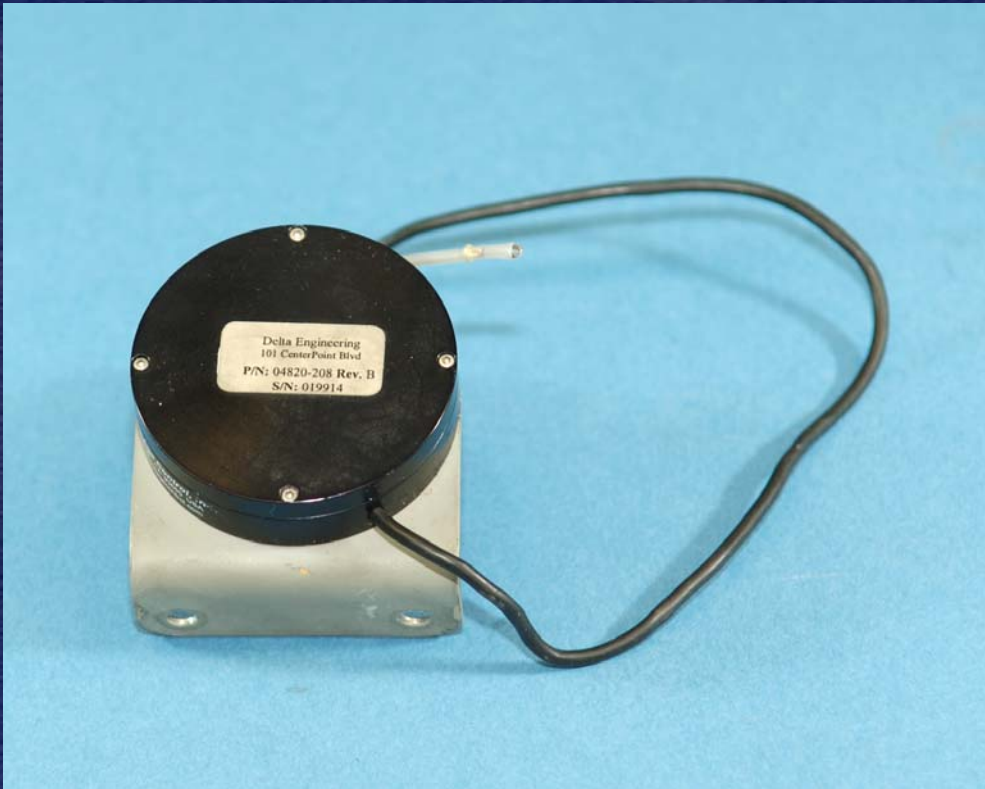
String Potentiometer

- String attached to aileron linkage
- Aileron movement detected by sensor
- Sensor produces voltage input
- Voltage converted to digital value
